9th Meeting of the Standing Committee
19th Meeting of the Advisory Committee

Report of the Intersessional Working Group
on Man-made Purpose built Bat Roosts

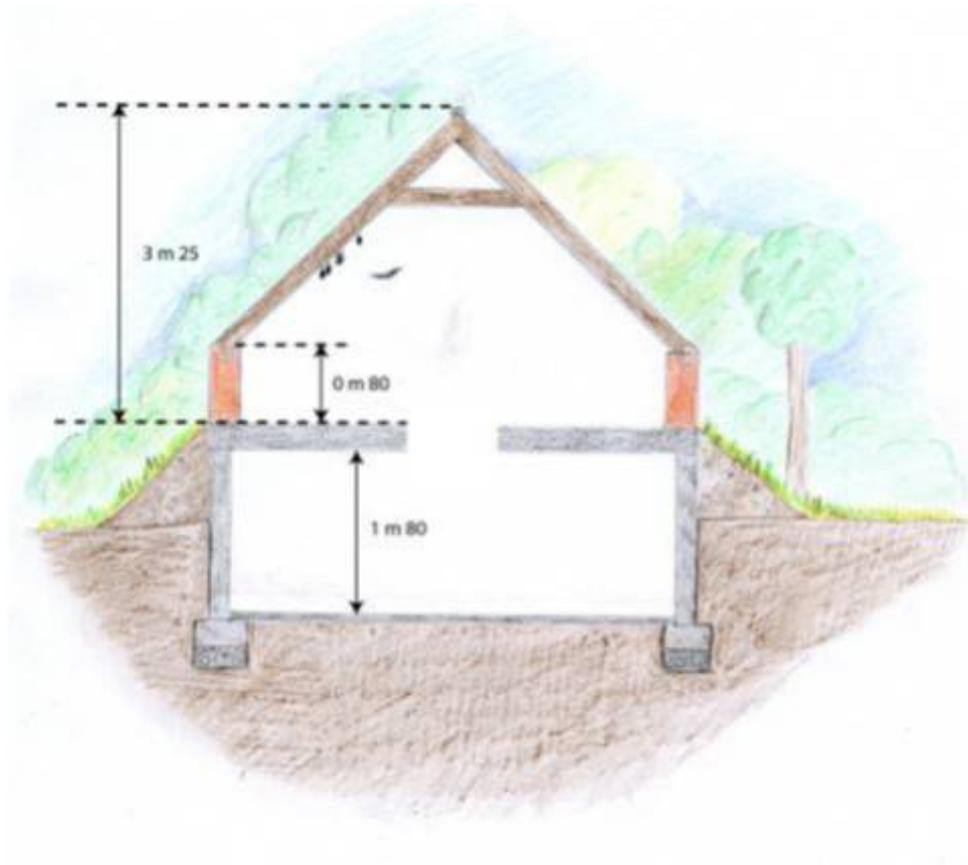
Sketch Plan of the new roost

The design incorporated both a maternity roost and hibernaculum. It took only a few months before the building was used as a hibernation site but five years before it was adopted as a maternity roost. The winter population numbers 124 individuals and there are some 100 bats in the maternity colony. The building is also used by *Pipistrellus pipistrellus* and *Myotis mystacinus*.

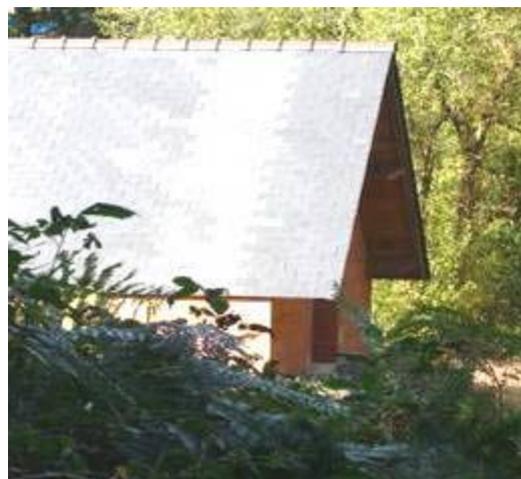
Photograph of the building

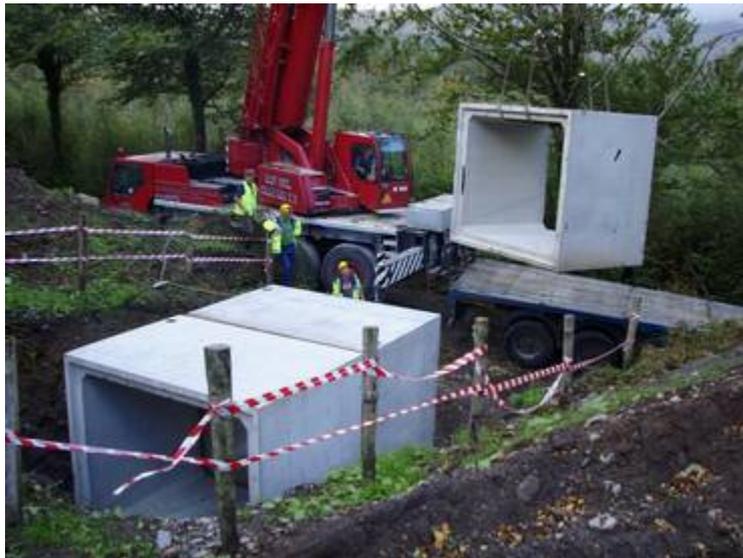
Four roosts, all for *R. hipposideros*, were reported from Ireland. These included a purpose-built hibernaculum constructed of pre-cast concrete culvert pipes.

Pre-cast culvert being loaded onto the site

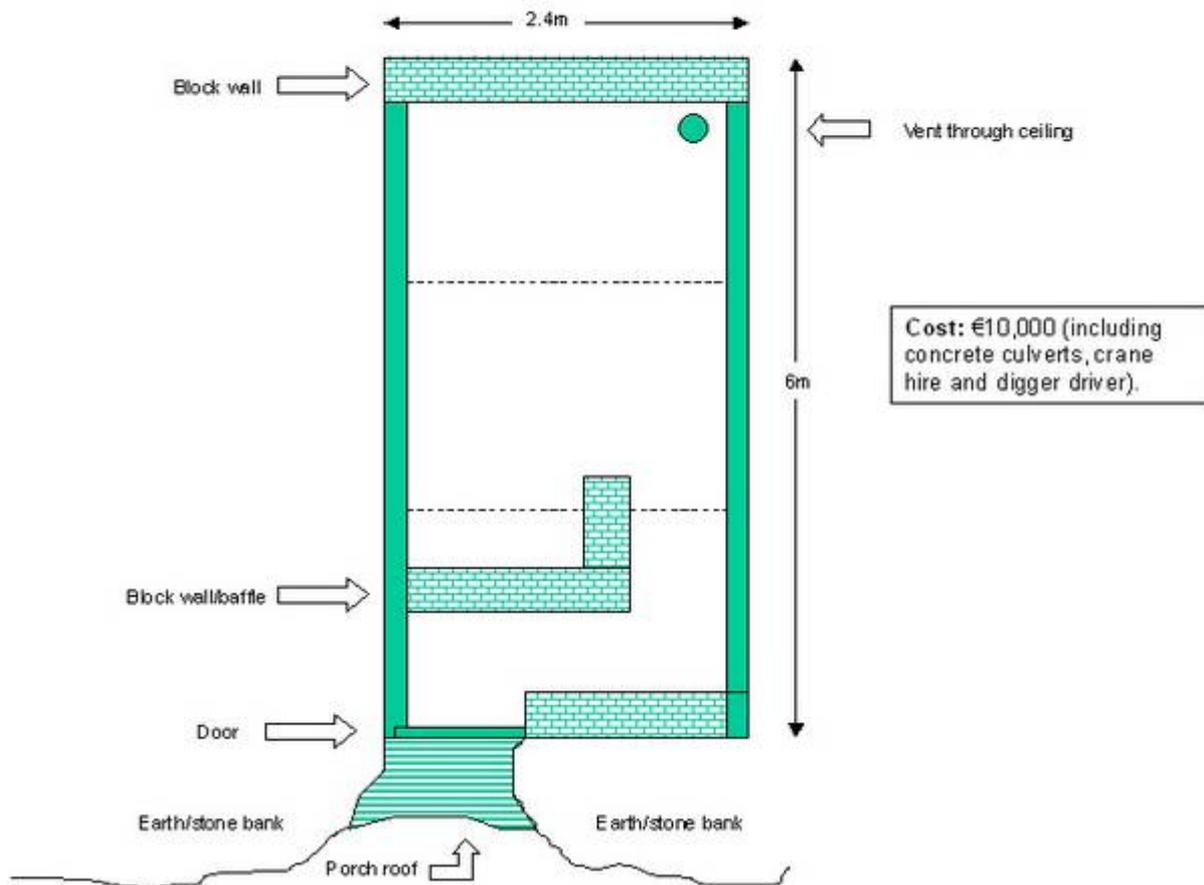
Flahives' Hibernaculum

A block-work wall formed the rear of the roost and a light baffle was built behind the entrance door.

Plan of the new hibernaculum

This structure has been used by 220 hibernating bats.

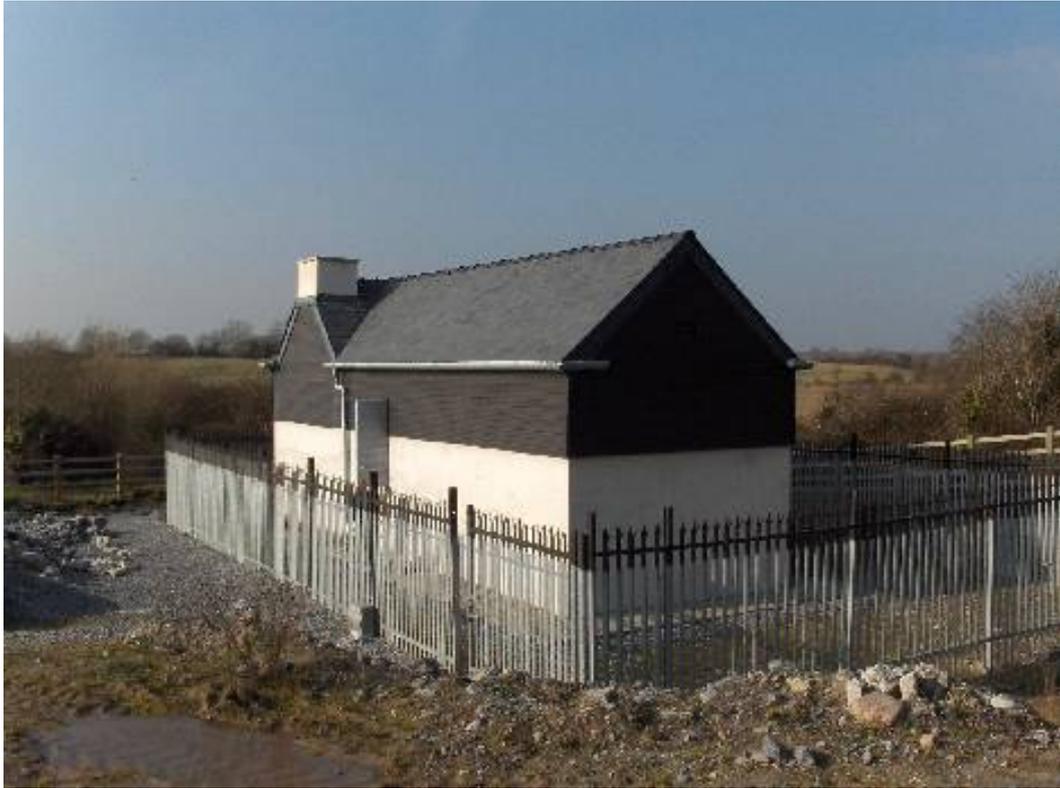
In County Clare, a new roost was built as mitigation for the loss of an original *R. hipposideros* roost due to a new road being constructed. The new roost was a three-storey building and like the example from France included a hibernaculum and maternity roost.

The new roost shortly after construction

Take up at the site has been slow; it took three years before bats were found to be using the building. To date only two bats have been recorded in the hibernaculum and one in the maternity roost.

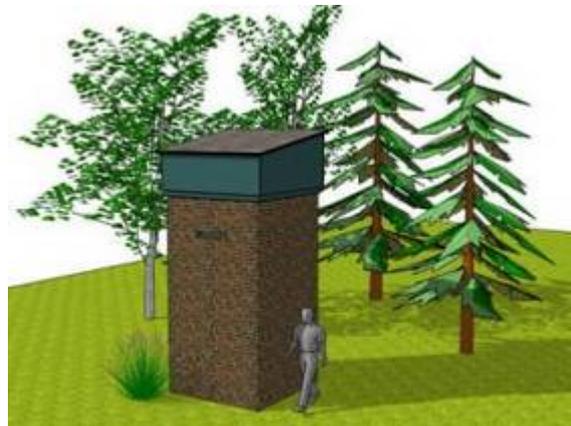
In the Netherlands a number of bat towers have been constructed. These are aimed at attracting *Plecotus* and *Myotis* species.

Artist's impression of the bat tower

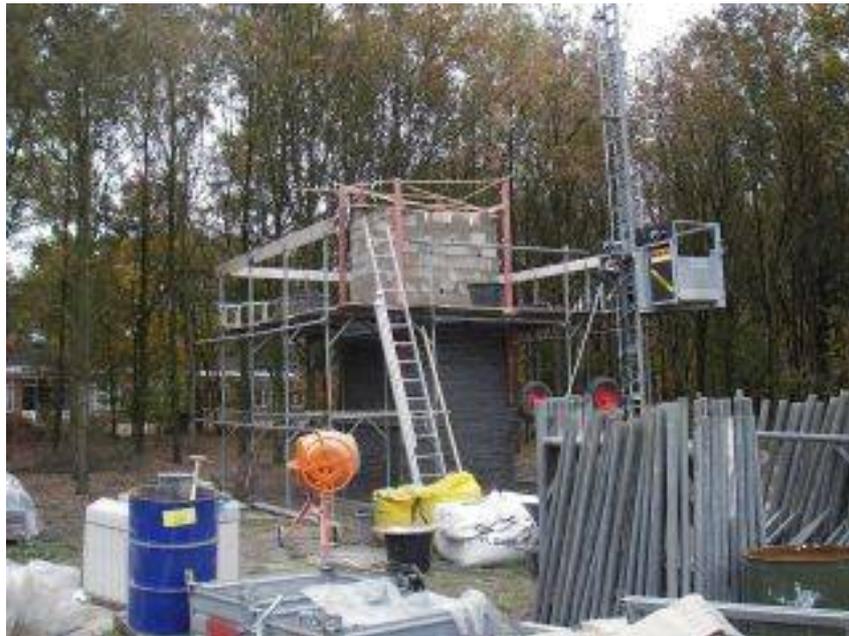
The bat tower during construction

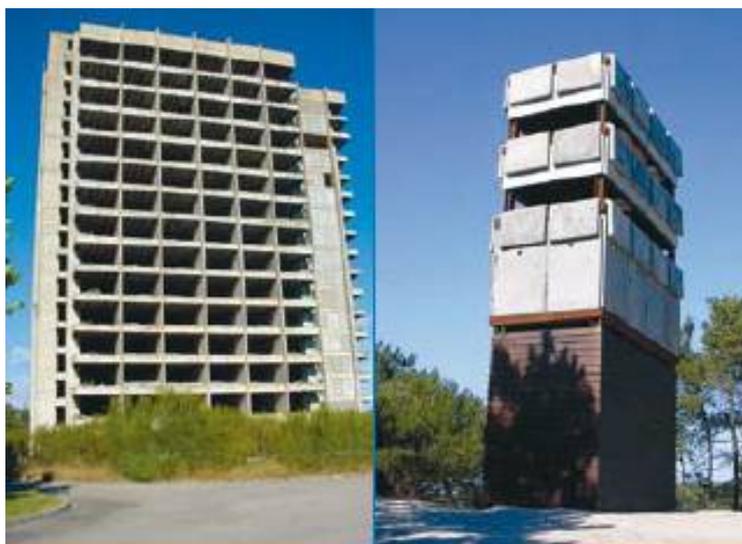
In Portugal a new roost has been successfully constructed following the demolition of a building used by *Tadarida teniotis*, *Eptesicus serotinus* and *P. pygmaeus*. The developer, in consultation with the Statutory Nature Protection Organisation, built a new roost 150m from the site of the original. Although it was smaller than the original roost it was designed to replicate its thermal characteristics. The new building has been used by all three species, although fewer in number than were found in the original site.

The original roost (left) and its replacement (right)

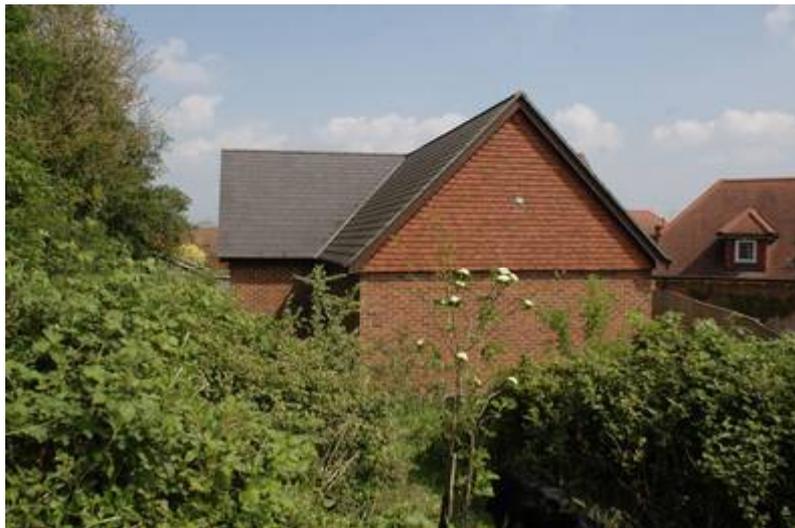
New roost on the edge of a housing development

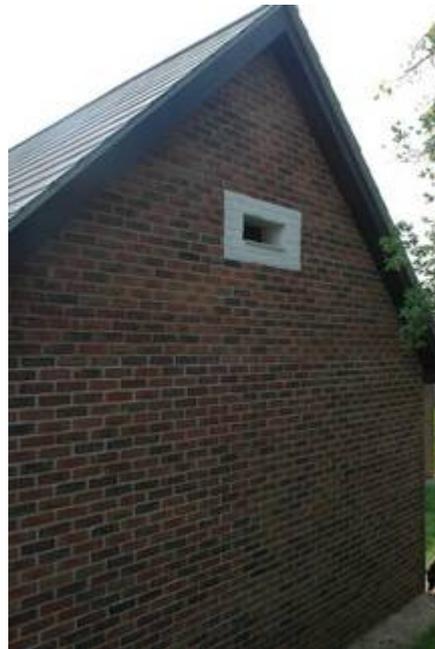
Entrance point for the bats on a shaded gable wall

This site is now used by a colony of some 180 bats

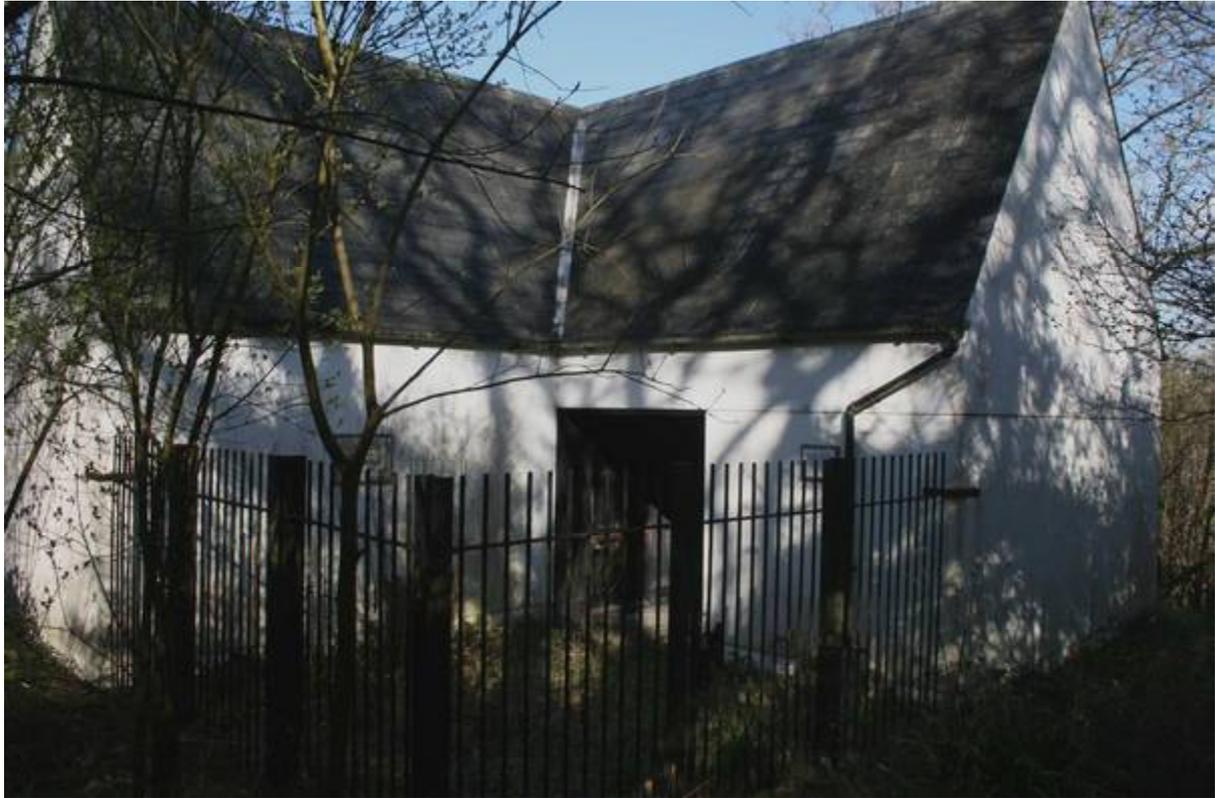
During the construction of a new road in southern England a nearby deserted cottage was vandalised and the roof slates were stolen. A colony of 12 *R. hipposideros* was found roosting in the chimney stack of the building but by this stage the structure had deteriorated so much it had to be pulled down. A new roost was built 100m away using an L-shaped ground plan. It was a number of years before the new roost was adopted by bats but it now has a colony of some 60 animals.

The L-shaped layout was designed to maximise solar gain

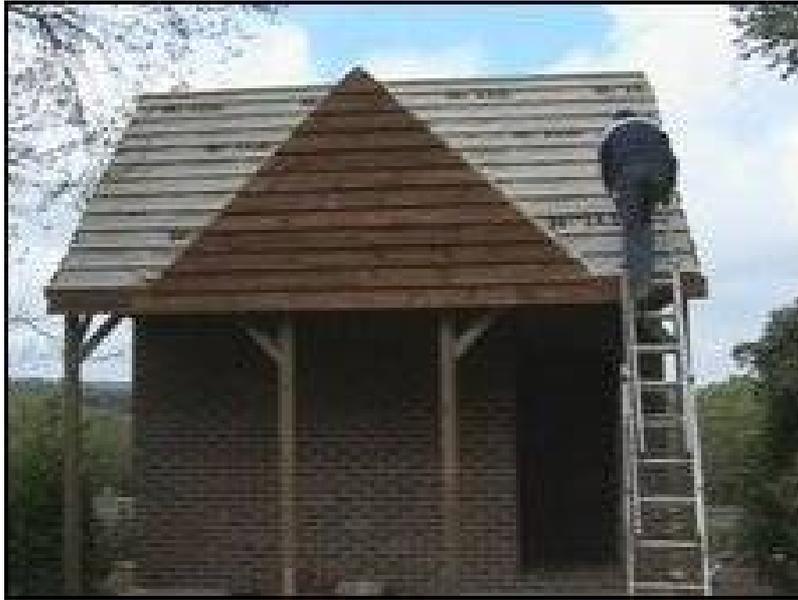
Apart from *Rhinolophus hipposideros*, the other species to benefit from purpose-built roosts in the UK is *P. auritus*. Following the demolition of a roost in south-east England to make way for new housing, a single room structure was built on the site to accommodate the bats.

New *P. auritus* roost
