14th Meeting of the Standing Committee

Tallinn, Estonia, 14 – 17 May 2018

Report of the Intersessional Working Group on Purpose-built Roosts

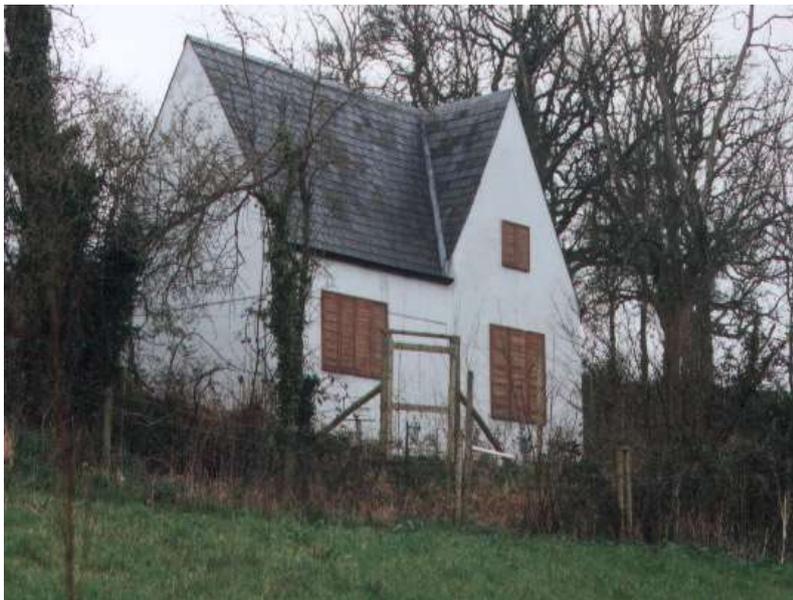
Figure 1. Bellaire Bat House. The false shutters were added to this building after construction to make it look less conspicuous.

The first of these bat houses to be built in Britain was in 1998, a new road development in southern England ran close to a small deserted cottage, which was found to contain a colony of less than 20 *Rhinolophus hipposideros*. The roofing slates had been partially removed and the building was in danger of collapsing and had to be demolished. The new roost was constructed some 100m away, similar in size to the original roost, the new building was constructed in an L-shape to improve the solar gain to the roof, which was also steeply pitched to create a wide range of temperature gradients inside for the bats.

The destruction of the original roost before the new bat house was constructed led to the colony deserting the area. It was two years before *R. hipposideros* started to use the building in small numbers and 11 years before a relatively substantial colony of over 60 bats were using the roost. The total cost of this building was £70,000.

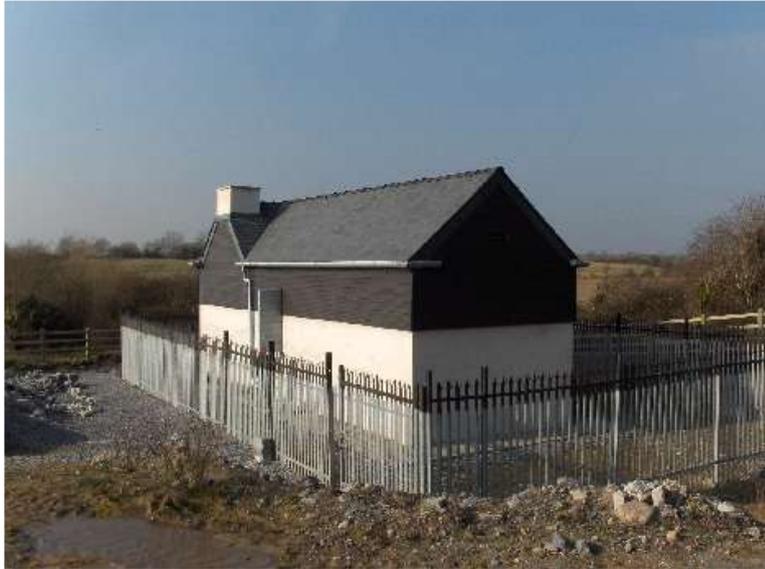
Figure 2. The Ennis bat house shortly after construction.

A more ambitious bat house for *R. hipposideros* was constructed near Ennis in the west of Ireland in 2005 as mitigation for a housing development. The building was 14m long and 8m high and made provision for a maternity roosting area in the roof as well as a hibernation area in the basement. It was built some 400m from the original roost, which contained a small colony of only 5 bats. Take up of the building by the local population of *R. hipposideros* has been very limited. After seven years only two bats were recorded hibernating in the site and one was observed in the roof void in the summer.

The reasons cited for the lack of uptake have been the potentially small population of *R. hipposideros* in the area and the availability of other suitable roosts. However, problems in the original design may have also contributed with the building lacking the humidity required by hibernating bats due to the floors having an efficient damp-proof layer. Some subsequent modifications have been made to the building and it continues to be monitored.

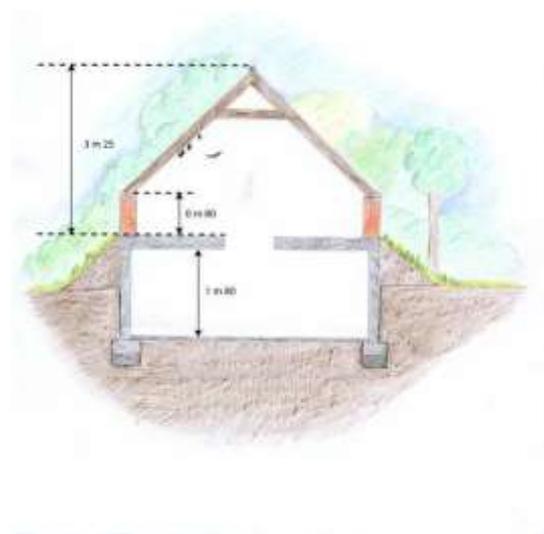
Figure 6. The new bat house for *R.ferrum equinum* in Finistère had a cellar for hibernation and a slate covered roof for a maternity roost.

In 1999 the Breton Mammal Group acquired land around a slate working in Finistère. This underground site was used by some 200 hibernating *R. ferrumequinum*, however, the maternity roost used by these bats had not been identified. In order to safeguard the future of the colony the group decided to undertake a purely conservation project to create a new maternity roost on the site. As with the Ennis bat house, this incorporated a hibernation area as well as spaces in the roof for a maternity roost. The project was funded by a consortium of organisations from local authorities, NGOs and foundations.

The building was relatively small with a height of 5m, width of 4m and the buildings was 6m long.

The site was adopted by hibernating bats within a few months but it took five years before a maternity colony was using the building. The overwintering bats number some 120 individuals with a maternity colony of 100 bats.

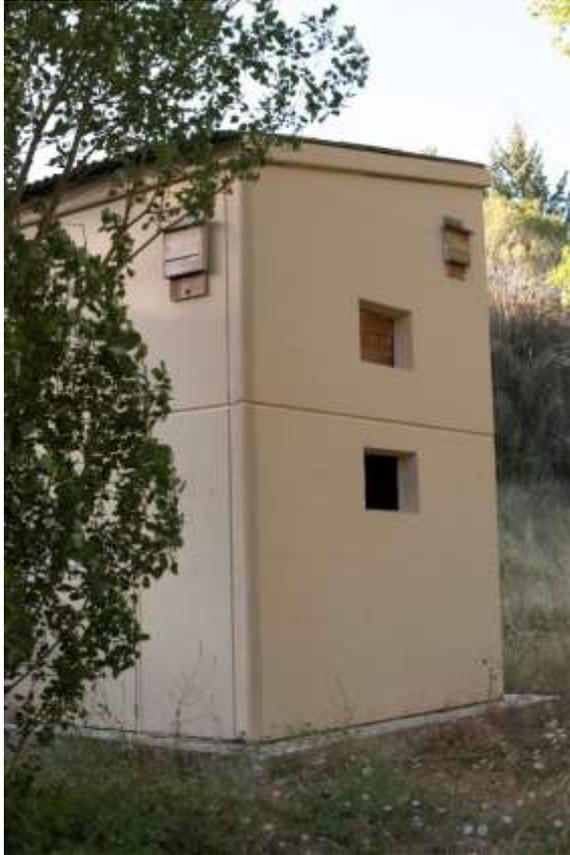
Figure 8. The larger *R. ferrum-equinum* roost made out of two sections.

The new sites were constructed of pre-formed concrete sections manufactured off site. The larger of the structures was 2.6m square and 4m high, the smaller was 2m square and 3.2m high. Both had smooth exteriors and rough interiors, wooden boarding was attached to the ceiling in areas to provide extra purchase for the bats.

Both new roosts have been successful with the larger site have a colony of 48 *R. ferrumequinum* and the smaller one 33 *R. hipposideros*. The *M. emarginatus* colony has also taken up residence in the larger of the two structures, although the numbers here have dropped from 200 down to 91 bats. Modifications were made to the buildings following the first year of monitoring, as evidence suggested the sites were over-heating and causing the bats to abandon them in hot weather. The exterior surfaces were treated with heat reflective paint and the roofs were modified to provide an air gap between the outer metal lining and the concrete ceiling. Both of these actions have reduced the extreme temperatures in the buildings and there have been no further abandonment of the roosts.

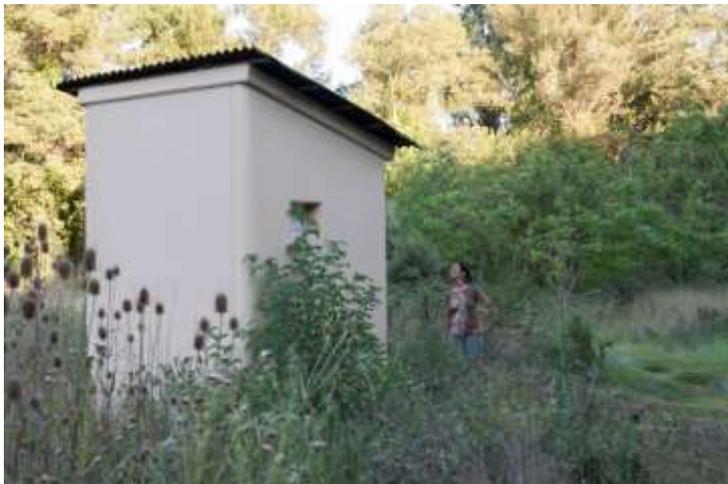
Figure 9. The smaller *R. hipposideros* roost.

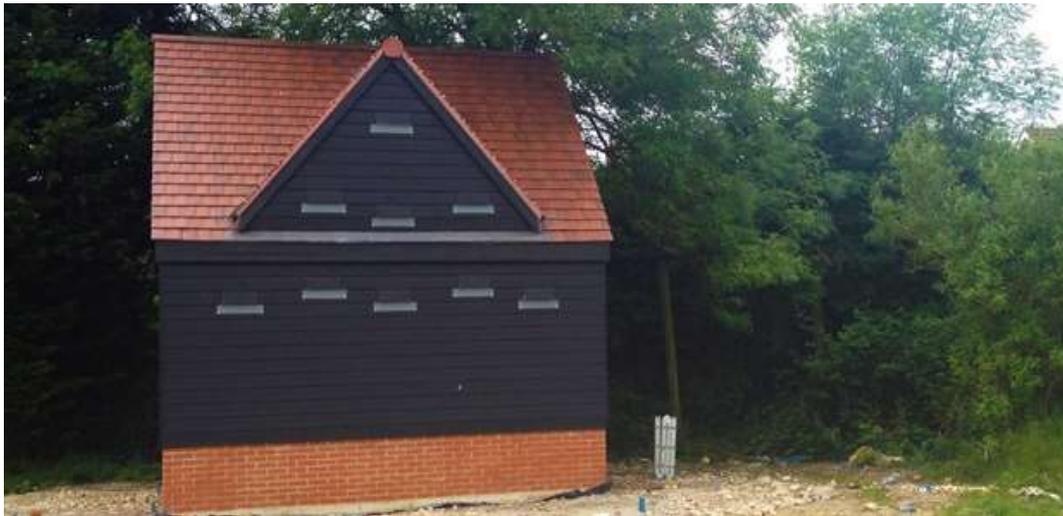
Figure 10. New built roost for Plecotus auritus with slot entrances for crevice dwelling bats.

A typical example of one of these structures is a new bat house at Brackley in the English midlands. The demolition of existing older buildings was undertaken to make way for a new housing development. The new bat house was constructed before the main development in order to allow the bats to become accustomed to the new roost. The new buildings was a square design and incorporated an open loft space as well as slot entrances and crevices for local *Pipistrellus* populations.

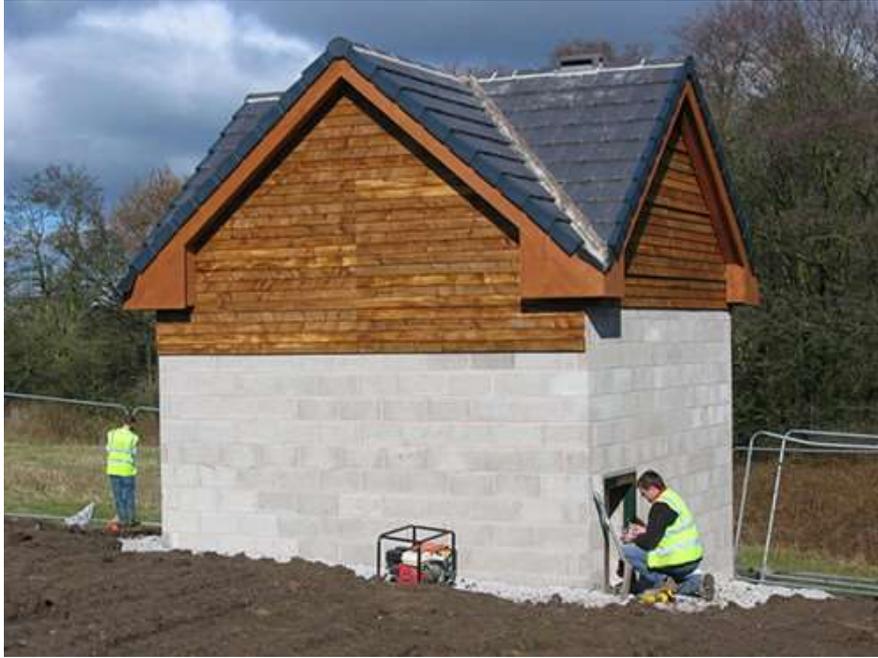
Figure 11. This roost was occupied by bats within five months of construction

A similar site was built in the north of England following the demolition of an ordnance factory. The roost followed a similar design to the Brackley bat house with block work walls and a tiled roof. Access points for the bats were via slot entrances in the gable walls and one of the ridge tiles.

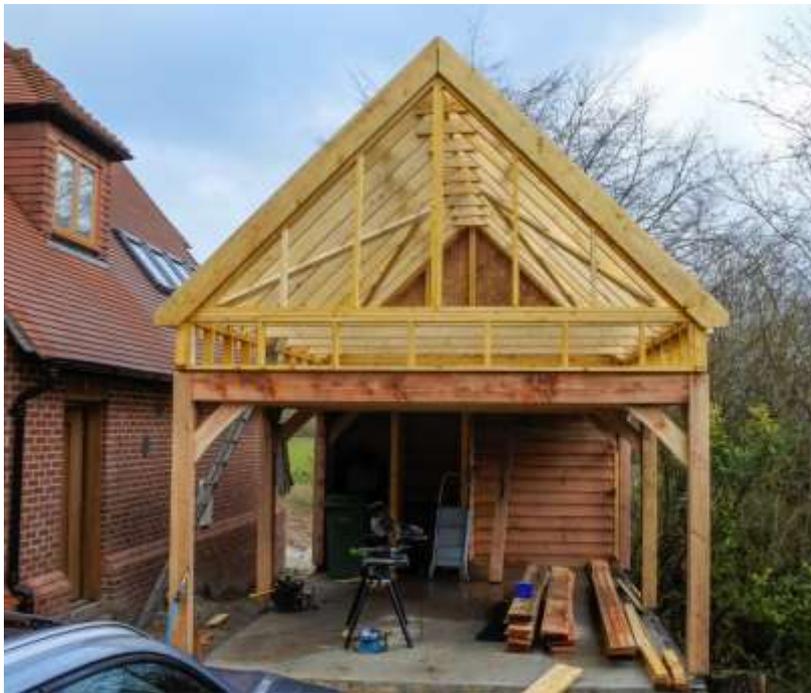
Figure 12. A dual use building with a garage below and bat roost above.

The funding of new build roosts is sometimes made more palatable for householders by incorporating areas of human use such as garaging for vehicles. This dual use building in southern England was also constructed for *P. auritus* bats. Figure 12 shows the open roof space under construction.

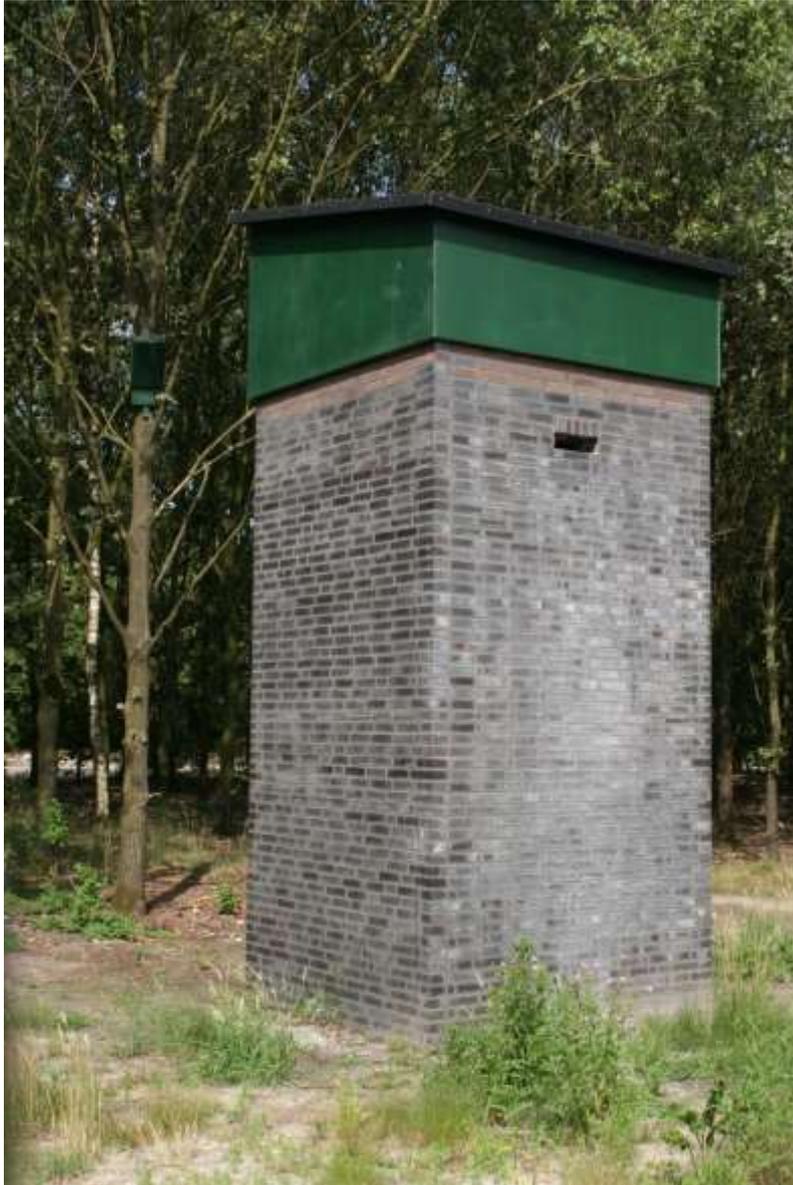
Figure 13. Dutch bat tower.

reproduce a whole suite of features found in the original roosts. The great advantage of these designs is the height. At 4m metres these bat houses maintain the elevation of the original roosts and their entrances. By building them so they have an aspect similar to the original roost and close to vegetation they try to reproduce similar microclimatic conditions to the roosts that have been lost.

These buildings are designed to be used by a range of species but particularly *Plecotus*, *Myotis* and *Pipistrellus* species.

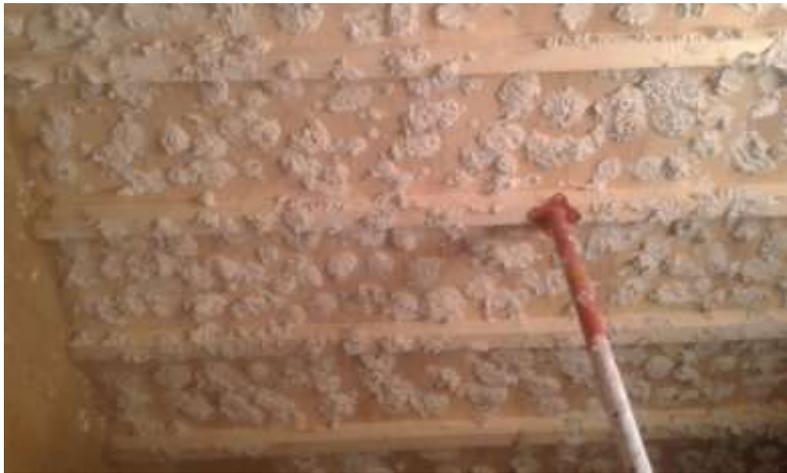
Figure 15. The rough surface on the ceilings provide the bats with perching sites

This project worked from scratch to recreate the buildings by manufacturing mud bricks in the traditional way and baking them in the sun. Roosting opportunities have been provided for the bats by creating holes and crevices inside the buildings.

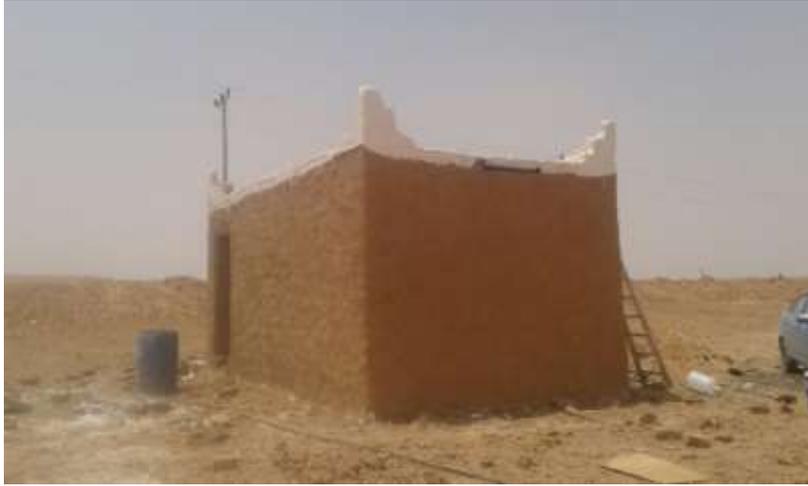
Figure 16. Newly constructed mud brick bat house.

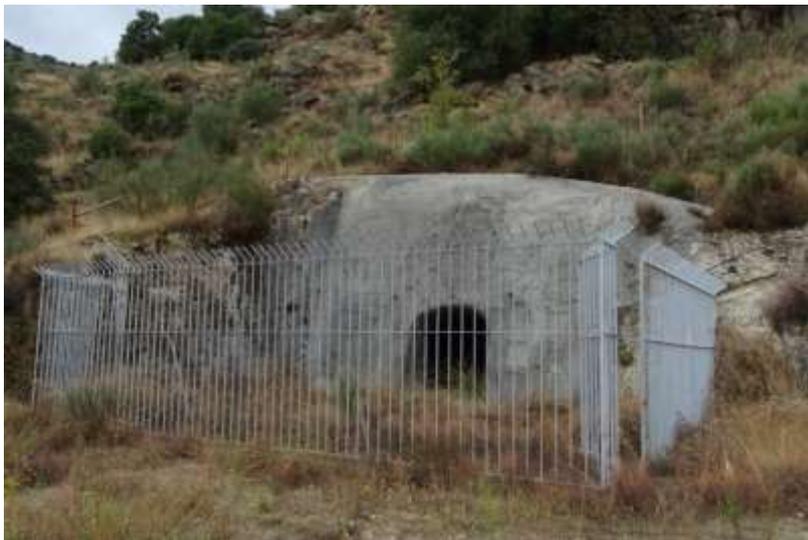
Figure 17. Fence entrance to new underground roost

A large number of species were affected by these developments including *R. ferrumequinum*, *R. hipposideros*, *R. mehelyi*, *R. mehelyi/euryale*, *M. myotis*, *M. daubentonii* and *Miniopterus schreibersii*. The developers were obliged to provide three replacement galleries to serve as alternative roosts. Surveys were conducted to determine the patterns of use of the original roosts along with data on temperature and humidity. The replacement roosts were located as close as possible to the originals, and were fenced in order to reduce disturbance (Fig. 17).

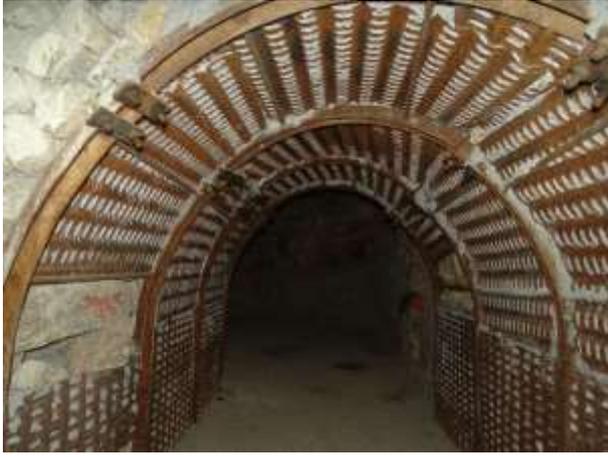
Figure 18. Excavated tunnel in the replacement roost

Tunnels were excavated in the rock which led to galleries of different heights. These height differences provided a range of different microclimates for the bats.

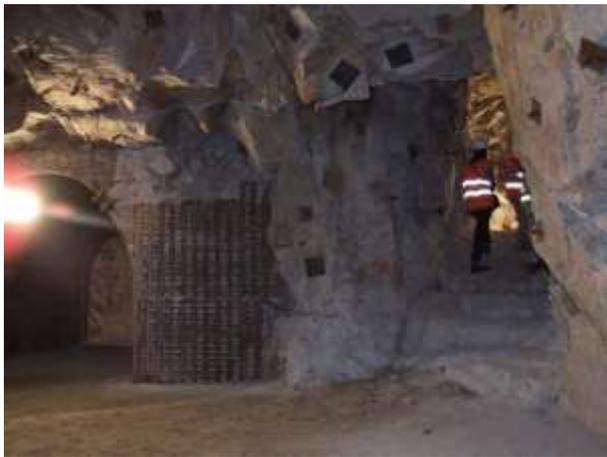
Figure 19. Galleries for the bats to roost in

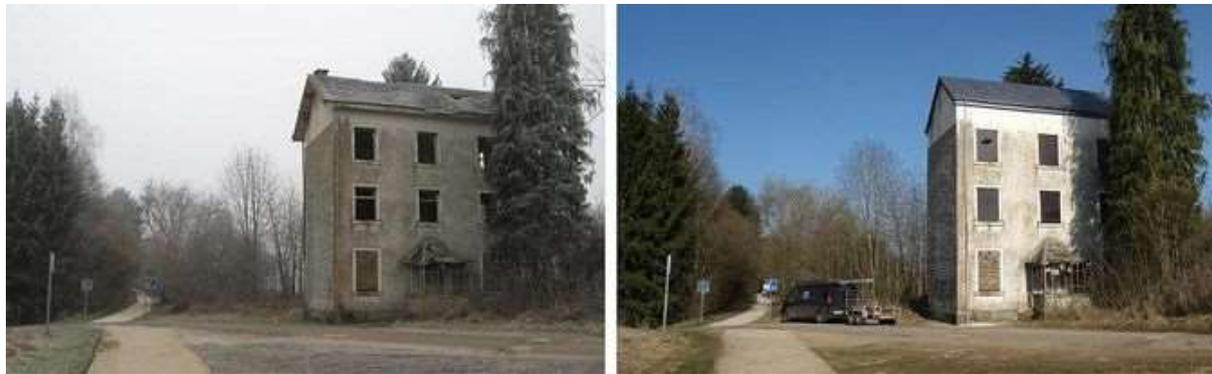
Figure 20. Before and after photographs of the old guard house in Viton

The privately owned building in Figure 20 was acquired on the 30 year lease by the local authority in Wallonia, Belgium. The project to adapt this disused house for bats intended to solve a number of conservation issues in the area. A roost of *Myotis myotis* locally was under threat by repeated disturbance and predation of the colony by *Martes foina*. In addition, there was a need to increase and improve roosting opportunities for local populations of *R. hipposideros*.

The building was re-roofed and shutters were placed over the open windows to make the interior darker for the bats. It was secured by metal doors on the ground floor to prevent unwanted access. Bat shaped entrance holes were cut into some of the shutters to provide access for the bats.

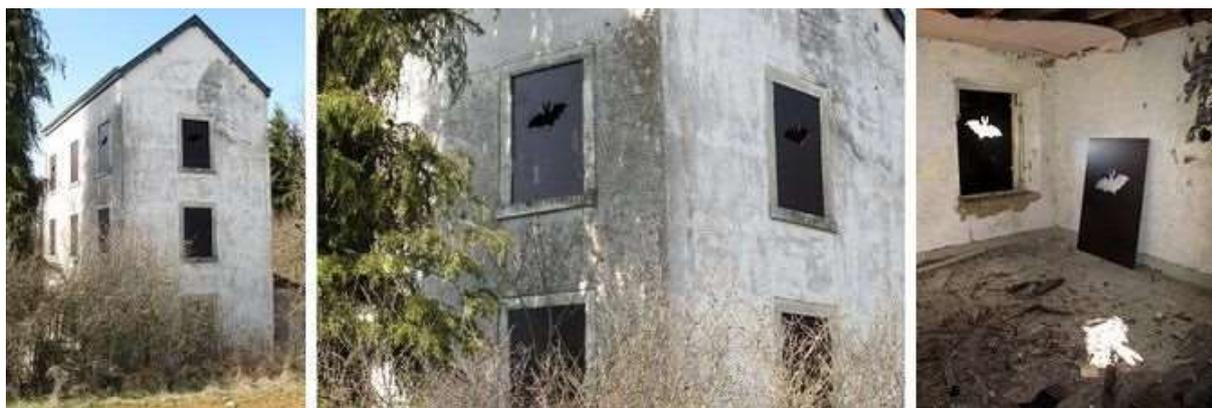
Figure 21. Photographs of the shutters and bat access holes

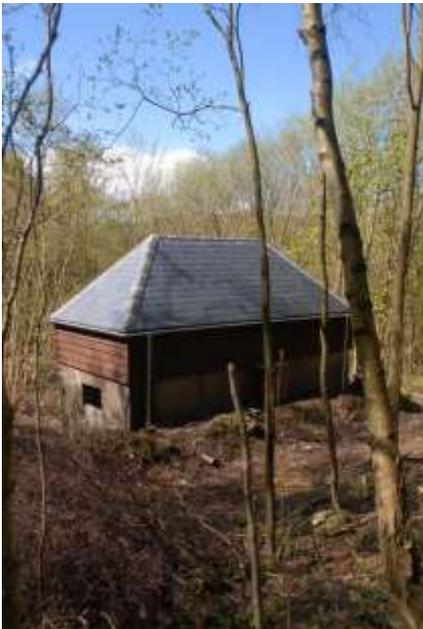
Figure 23. The completed conversion to a bat house

The roof of the wages office was lifted to provide a large void for the bats. As it was surrounded by trees and partially shaded, the ends of the roof were hipped to increase the solar gain to the building. The ground floor windows were blocked up and a new grilled entrance was added. Within three months *R. hipposideros* droppings were found inside the site and over the following two years day roosting bats were found in residence. After ten years the building is now occupied by a maternity colony of over 100 animals.

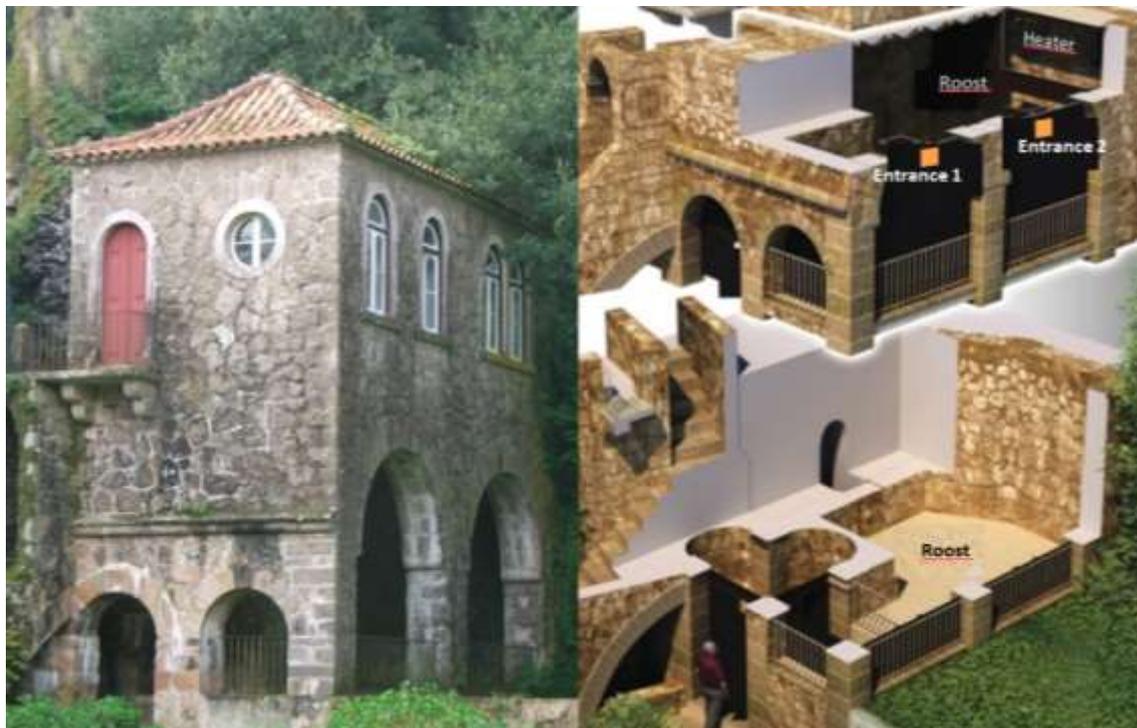
Figure 24. A photograph of the new roost building, along with a cutaway graphic showing the location of the roost, the entrances and the location of the heaters.

Morcegário da Regaleira, a building located 30m from the temporary roost was chosen. The room was approximately 7m long, 3 wide and 5 m high. Following modifications to the building guano was placed in the roost and a small number of bats were translocated there. Over the following two years only individual bats were recorded using the new roost. Following the installation of a heater into the space the colony finally moved and started to breed in the site, allowing the temporary roost to be closed to the bats. In addition to the maternity use of the site by c200 bats, smaller numbers of *R. hipposideroscan* be found in the building throughout the year. The site is also now used by small numbers of *R. ferrumequinum*, *R. euryale* and *Plecotus sp.*

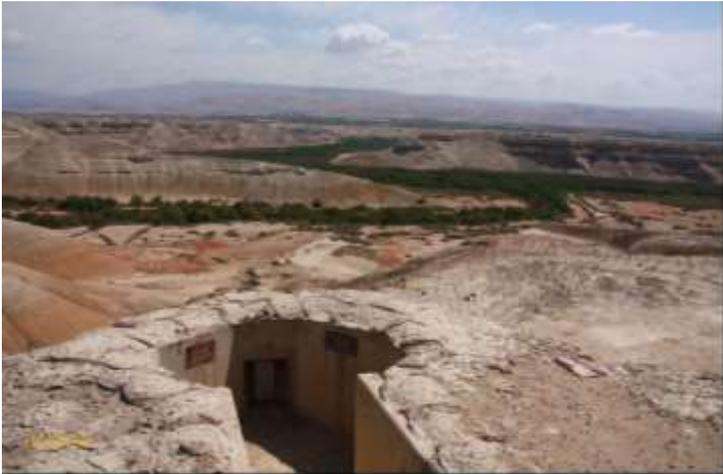
Figure 25. Entrance into the modified bunkers

in a lack of suitable surfaces for the bats to hang from. The project addressed this issue by roughing up the smooth ceilings of the bunkers by using polyurethane foam and cement. Plastic netting and wires were also attached to these surfaces.

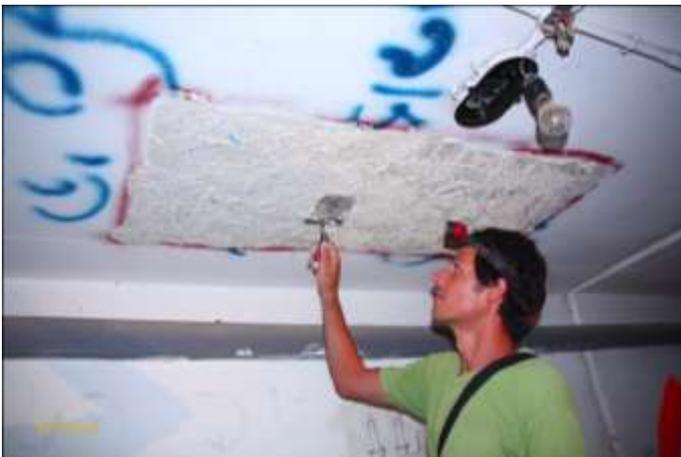
Figure 26. Roughing up the smooth ceilings

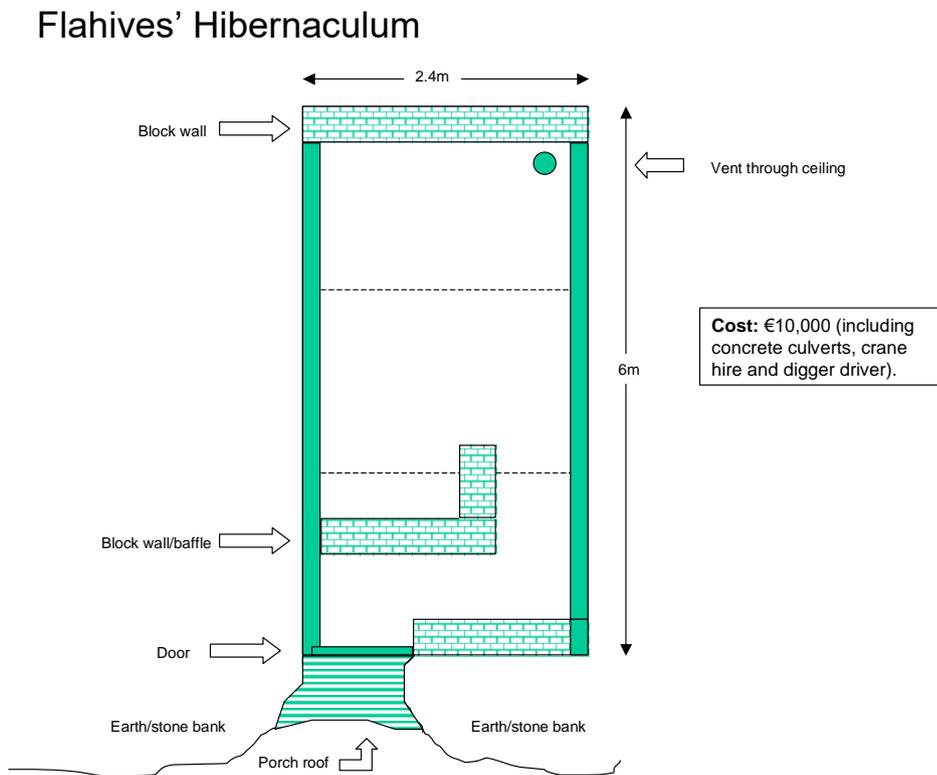
Figure 27. The ground plan of Flahive's hibernaculum

Flahive's hibernaculum in the west of Ireland was constructed to improve the resilience of a maternity colony of *R. hipposideros* that roosted in a building close-by. An earthen chamber had been dug into the site some eight years previously and although this had been used by small numbers of bats, it was starting to collapse and a new more robust hibernacula was needed. The front and back walls of the new structure were built using blockwork and the main chamber was formed by pre-cast concrete tubes. A block work baffle reduced air movement and reduced the light entering the chamber. The front and back walls of the new structure were built using blockwork and the main chamber was formed by pre-cast concrete tubes. A block work baffle reduced air movement and reduced the light entering the chamber.

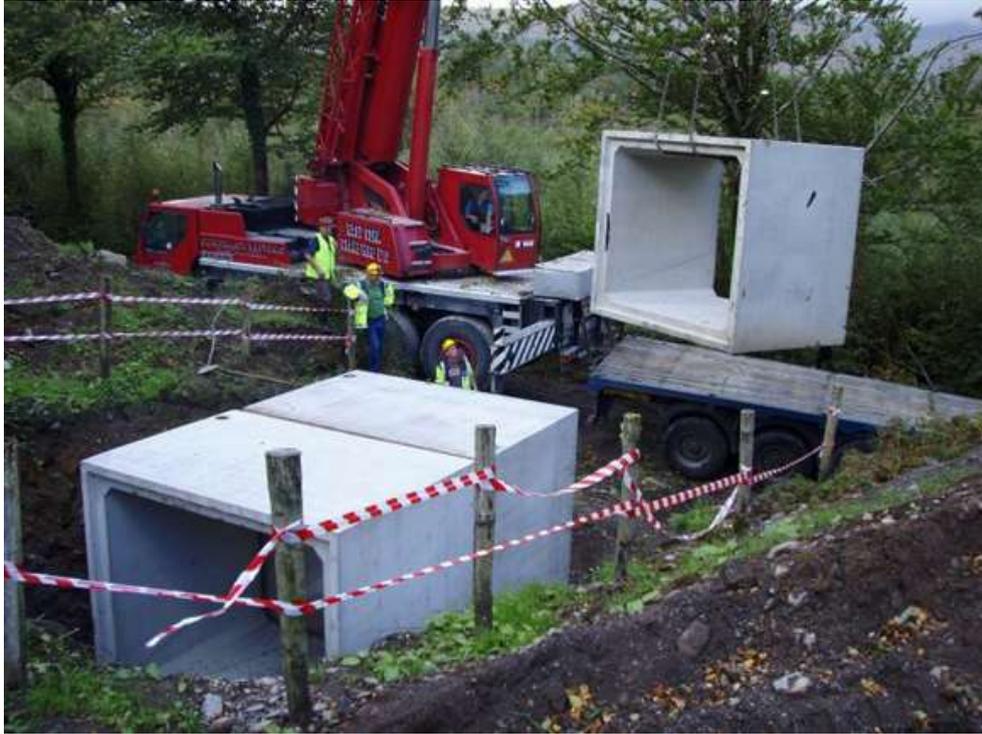
Figure 28. Square profile pre-cast concrete sections being loaded into place.

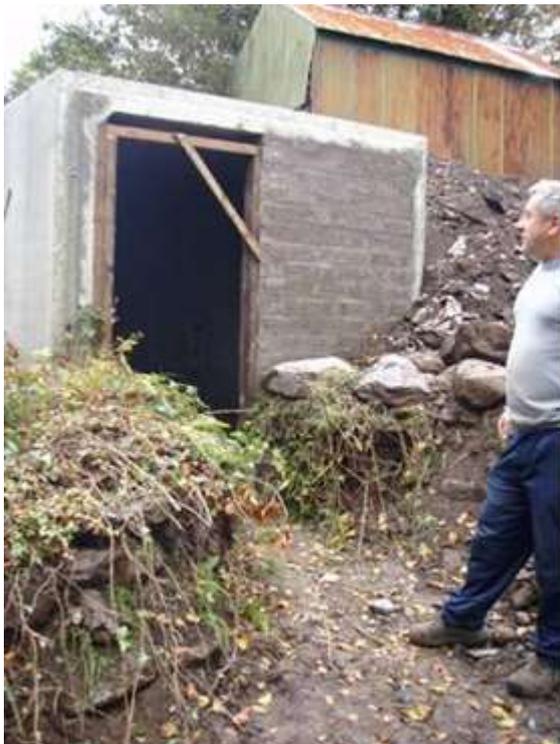
Figure 29. The new hibernation site before it was covered in earth

The structure had a door with a window to allow the bats access and was covered with earth and vegetation to provide insulation. The new hibernation site was a great success and in the five years following its construction the number of *R. hipposideros* using the site increased to two hundred.

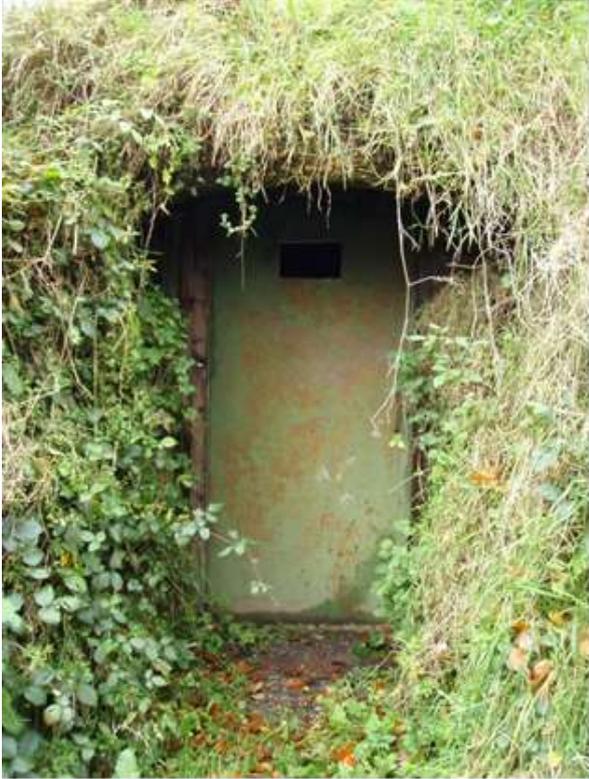
Figure 30. The entrance to the completed structure

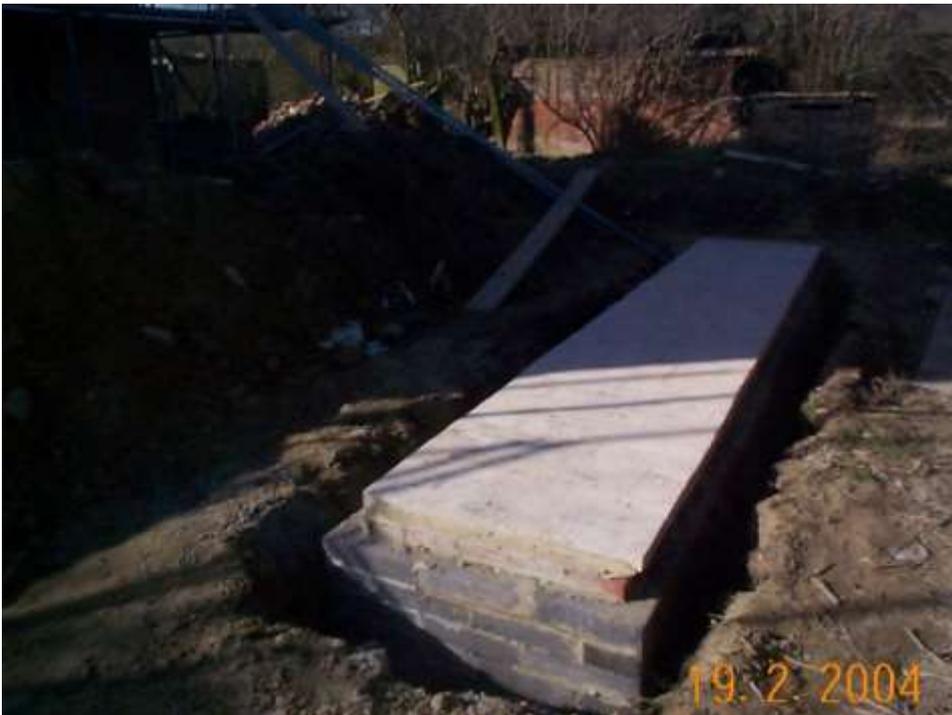
Figure 31. Part of the blockwork tunnel system connected to the maternity roost before it was covered over with earth

Directly linking purpose-built hibernation sites for Rhinolophids to their summer roosts can be very effective and provides the colony with all year around roosting opportunities. At a site in south-west England a simple tunnel was built using a cast concrete floor and ceiling with blockwork walls. The entrance to the L-shaped tunnel was located in a ground floor room of a disused building that was home to 150 *R. hipposideros*.

The tunnel ended in a small chamber where most of the bats hibernate. A small chimney at the end of one of the tunnels maintains some air-flow through the system and holes in the blockwork walls allow some water movement and keep the humidity levels high.

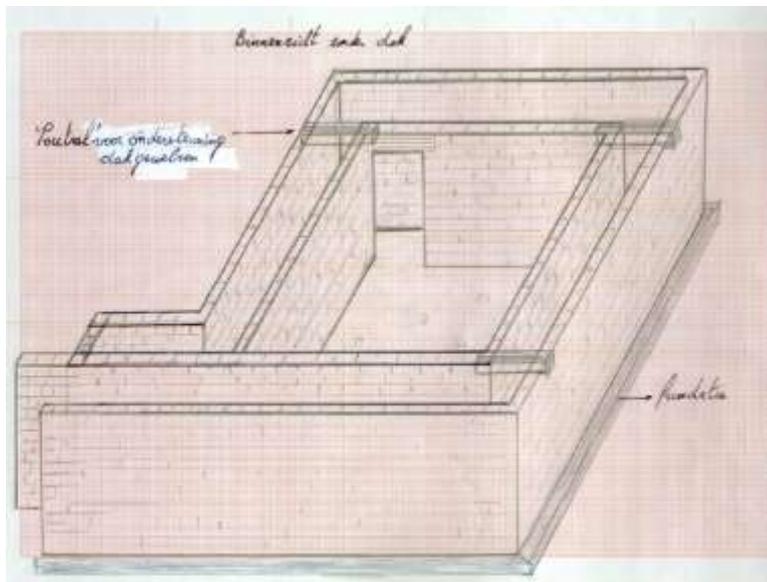
Figure 32. A sketch plan of the Tilligem bat cellar.

These relatively simple open structures work well for *R. hipposideros* but the provision of numerous crevices and hollows are required when sites are being provided for most Vespertilionid bats. A number of purpose-built hibernation sites have been constructed in the Belgium. One of the simpler ones of these was built at Tilligem and consisted of a central room with a collider running around the outside of it. This is a typical design for ice-houses in the area.

The floor of the hibernation site is made of concrete and holes have been drilled into this to allow the water to build up in part of the corridor, this not only increases the humidity but discourages human disturbance. The site is on public land and there were fears around the site being vandalised, the water level in the corridor is such that waders are needed to access the main chamber.

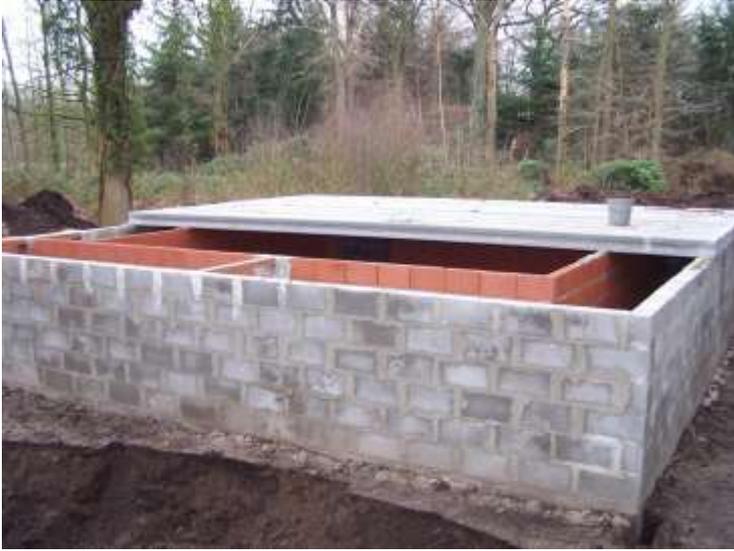
Figure 33. Showing the solid concrete walls and the lighter internal one.

The outside walls of the structure are made of concrete blocks, the inner walls of light-weight building blocks.

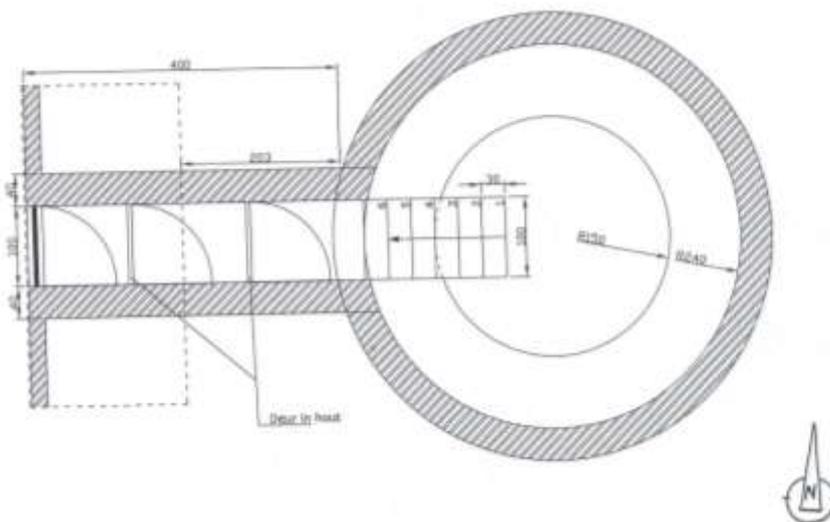
Figure 34. The ground plan of the Bulskampveld hibernation site

Taking the idea of constructing ice houses a stage further a project at Bulskampveld in Belgium recreated a traditional dome shaped example. A 4m long service tunnel, with a series of internal doors, led to a round chamber with a radius of 3.6m

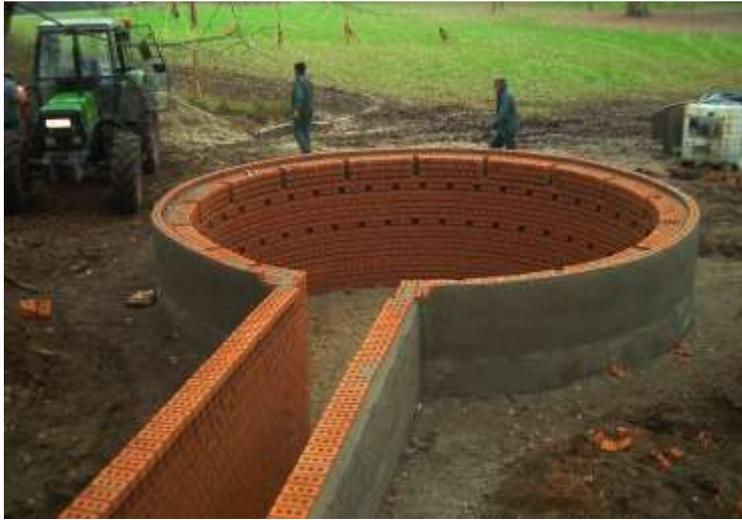
Figure 35. The Bulskampveld hibernation site part way through construction

Numerous gaps and crevices were provided for hibernating bats in the wall of the structure. The contractors built a dome of straw and sand on top of the chamber and used this as a forma for

building a brick dome on the chamber.

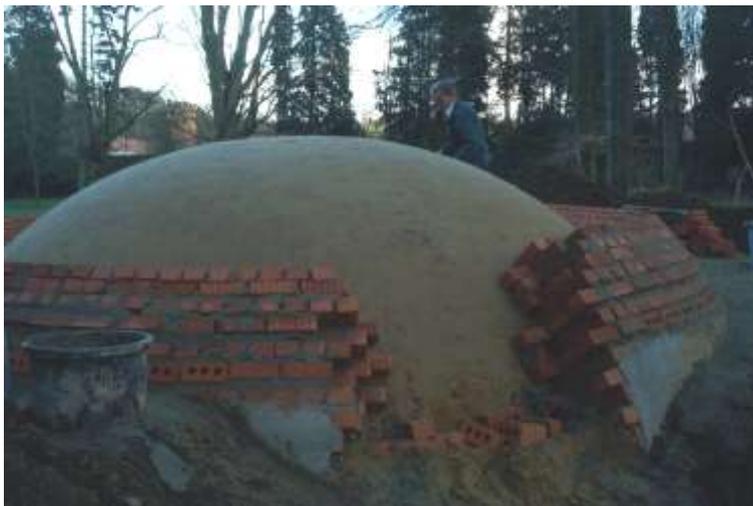
Figure 36. The brick dome being built over the straw and sand forma.

When the dome was complete the straw and sand was removed from the inside of the chamber. The structure was then covered with earth and planted up.
